Outline PCB Hot Spot TCRA

Hunters Point Naval Shipyard BCT Meeting – January 26, 2012_4

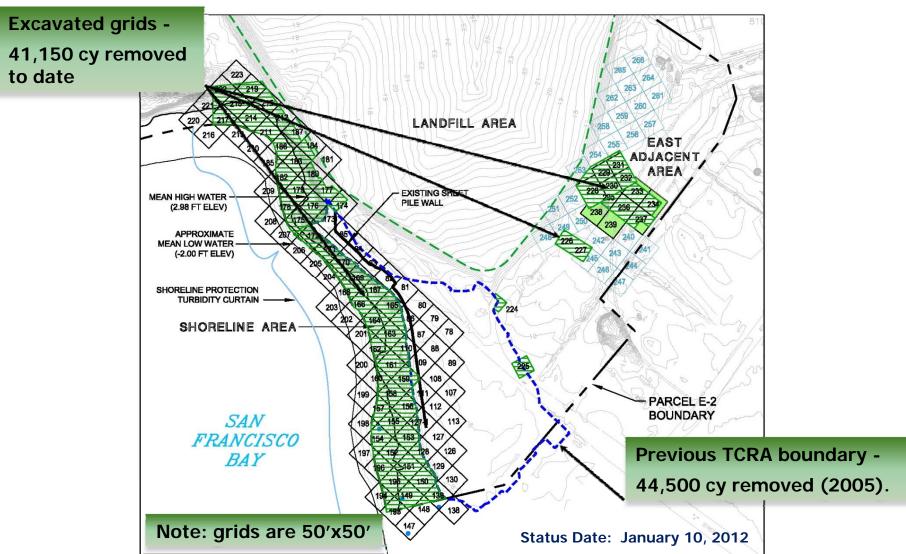
TCRA Progress – Excavations Complete

- 100% of grids (47) excavated, sampled, and backfilled
- Over-excavated 16 of 47 grids to <PALs or 10 ft bgs
- Over-excavated an additional 6 of 47 grids to 12-16.5 ft bgs
- Over-excavated 2 sidewalls
- 21,771 cy excavated
- PAL exceedances for PCB or TPH in 10 bottom samples remain (below 10 ft bgs or deeper)
- PAL exceedances for PCB or TPH in 14 sidewall samples remain (along Parcel E and F boundaries)
- Southern boundary (along Parcel E) marked with snow fence for future delineation
- Placement of temporary shoreline revetment complete

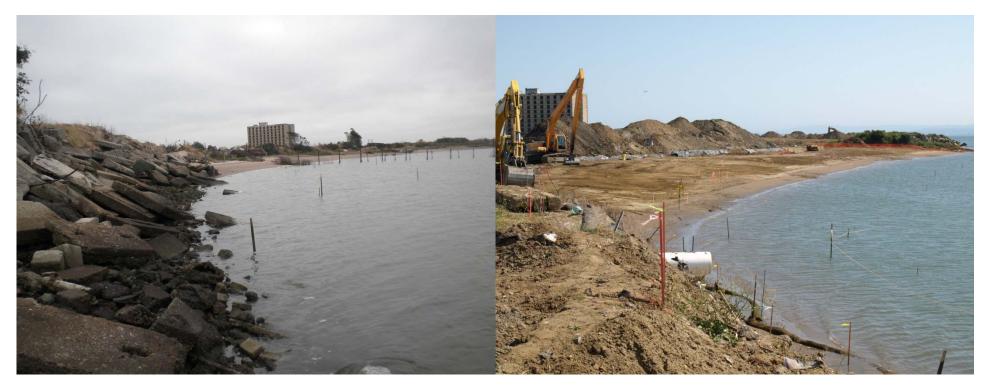
View of Tier 1 looking south before TCRA July 6, 2010

View of Tier 1 looking south during field work September 13, 2011

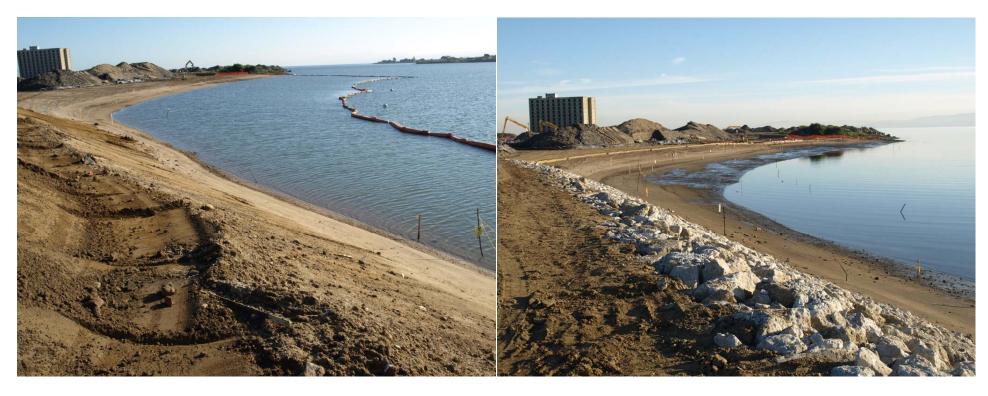
View of Tier 1 looking south upon completed excavation work and prior to placement of temporary revetment; turbidity curtain still deployed November 16, 2011

View of Tier 1 looking south; revetment complete and turbidity curtain demobilized

January 12, 2012

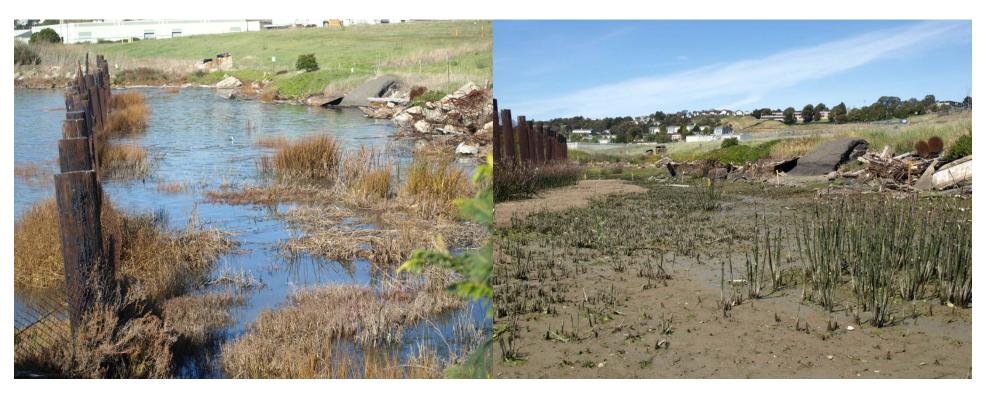
Tier 2 prior to TCRA at high tide looking north November 17, 2009

Tier 2 wetland area at low tide looking north June 4, 2010

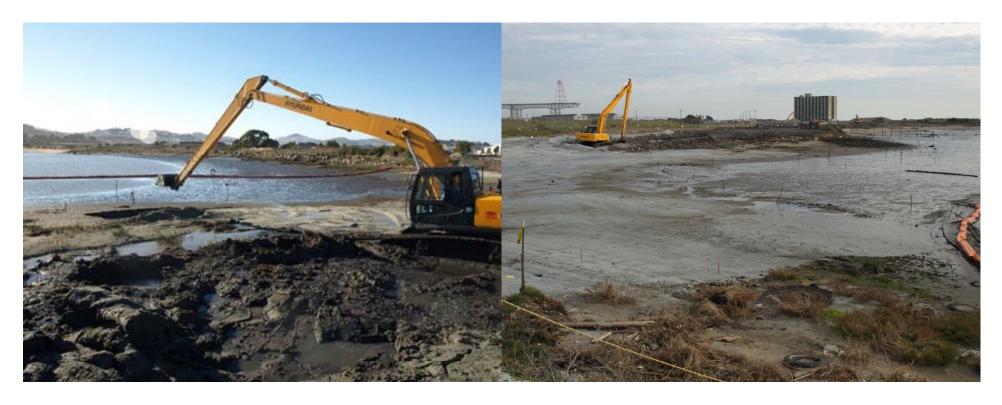
Backfill placement in Tier 2 at low tide October 26, 2010

Excavation of Tier 2 during low tide event December 1, 2010

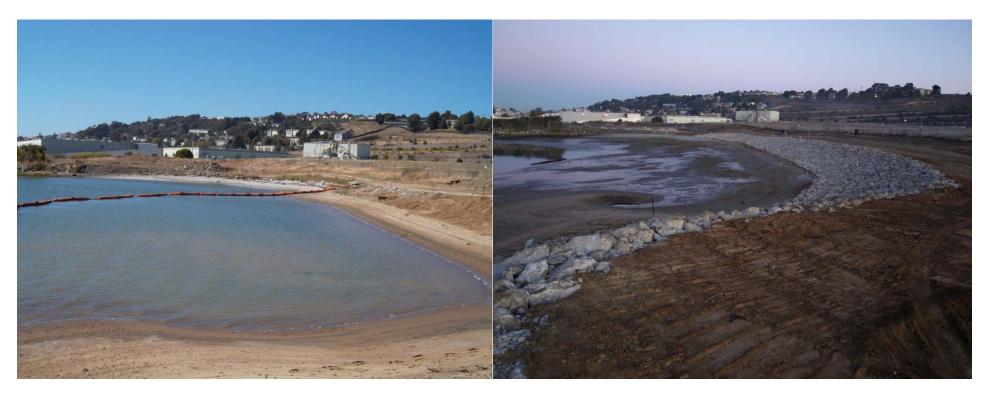
Excavation of Tier 2 complete; prior to placement of temporary revetment August 16, 2011

Tier 2 looking north; placement of temporary revetment complete and turbidity curtain demobilized

January 12, 2012

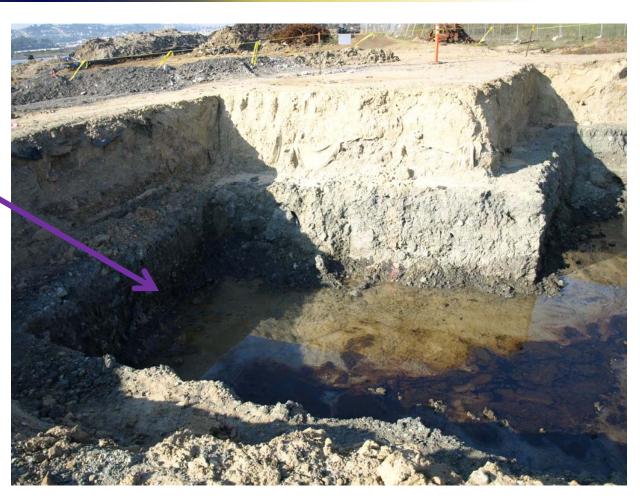
8' SW sample TPH = 15,907 mg/kg

TPH PAL = 3,500 mg/kg

Southwestern section of Grid 224 with visible TPH looking east. Confirmation samples show that northeastern section meet PALs

December 7, 2011

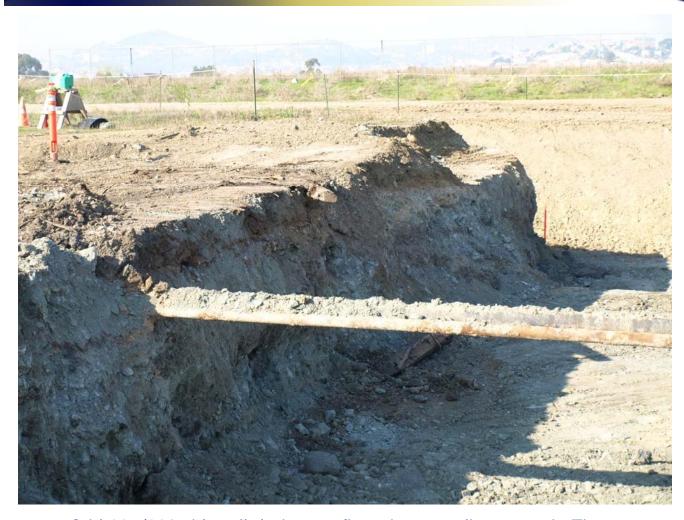
Grid 235/238 sidewall during confirmation sampling event in Tier 5 facing northeast December 7, 2011

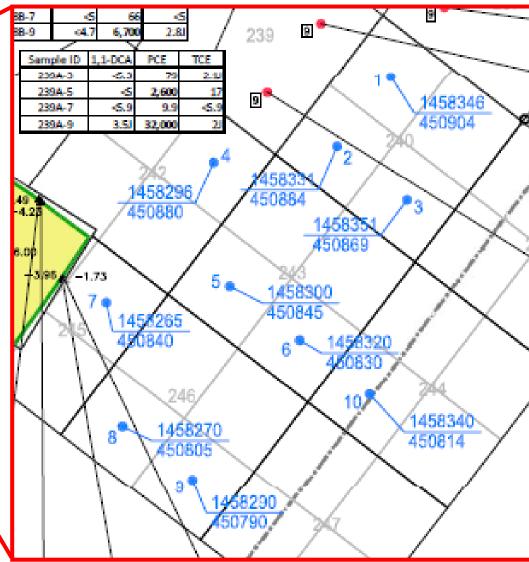
Tier 5 - Potholing

- 8 locations selected for further characterization (VOCs) outside area not excavated
- Northing and Eastings established

Note: Locations 8 and 9 were not sampled because data from previous soil gas sampling show no presence of VOCs.

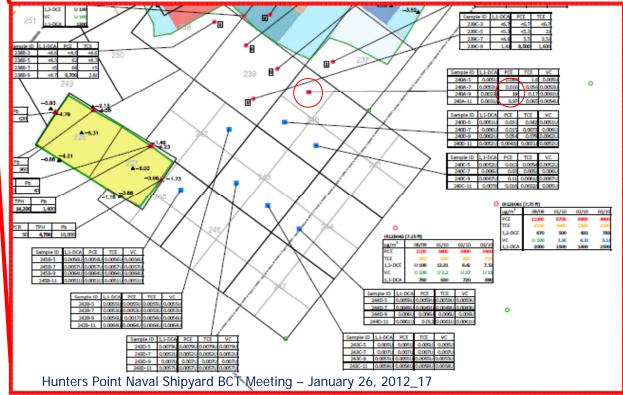
Tier 5 - Potholing

- Potholing complete 1 of the 8 locations had PCE above PALs (PCE 19 ppm in Grid 240 at 9 ft bgs)
- Pre-TCRA characterization sampling (March 2010) shows exceedances in 5 quadrants
- Some PCE hot spots to be addressed with limited additional excavation (~550 cy).

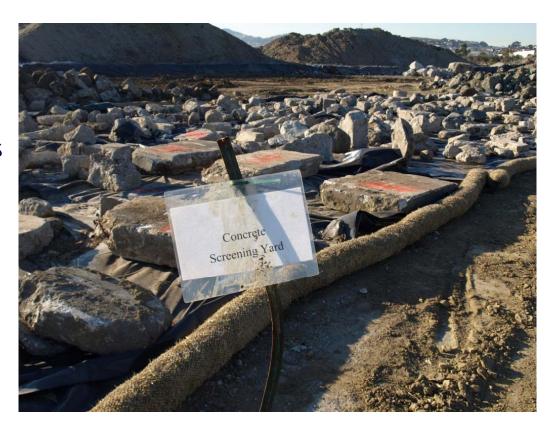
Concrete laid out for 100 percent screening prior to sizing and reuse as temporary revetment.

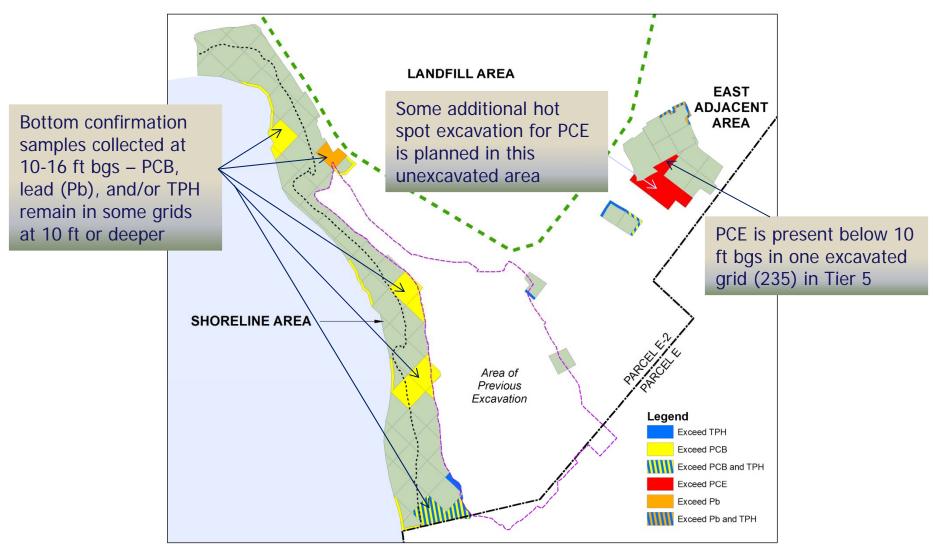
Update - What Get's Left Behind (Cont'd)

- Tier 1
 - TPH and PCB exceedances along Parcels E and F boundaries
- Tier 2
 - TPH and PCB exceedances along Parcel F and PCB and Pb exceedances in grid 174 along Landfill
- Tier 3
 - Grid 231 sidewall (PALs exceeded for TPH and Pb)
 - Grids 224, 226, and 227 sidewalls (PALs exceeded for TPH and PCB
- Tier 5
 - Grids 235, 238, 239, and 240 (PALs exceeded for PCE >5 ft bgs)
